Control of  
Cabomba,  
Eurasian Milfoil  
and Water Lily in  
Lake Quonnipaug  
with Herbicides  
and Hydroraking  
2002

BY GREGORY J. BUGBEE  
AND JASON C. WHITE

*Bulletin 1002  
June 2005*

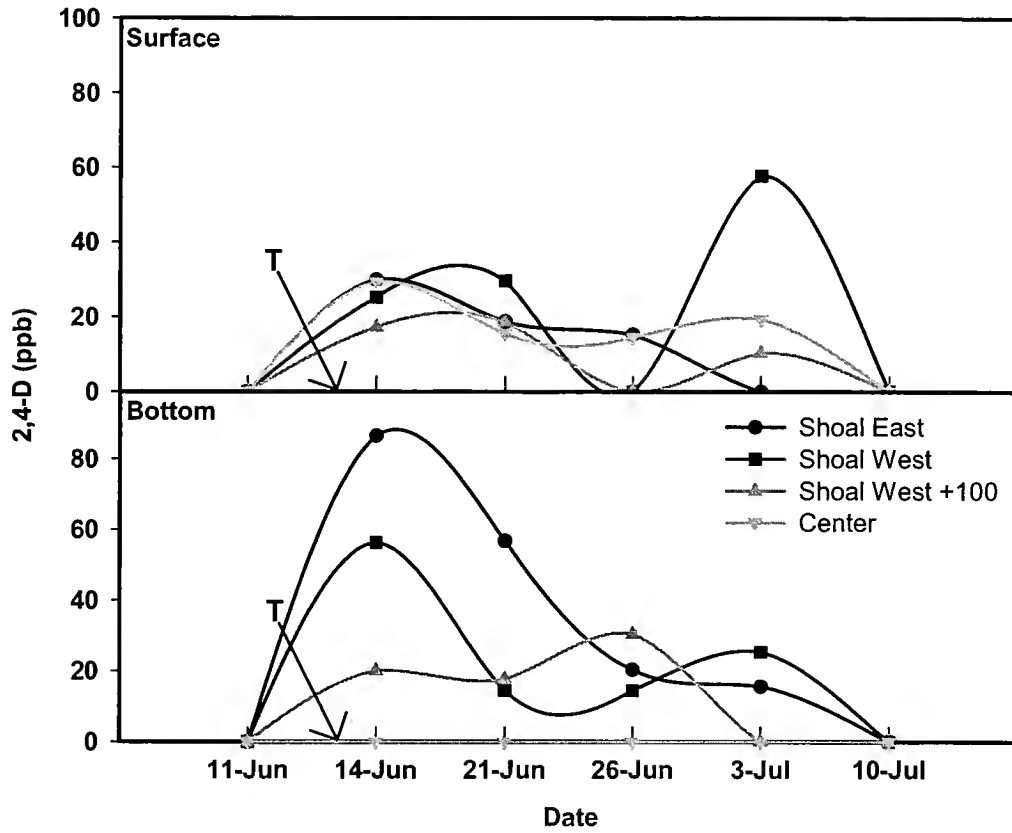
Figure 4. Concentrations of 2,4-D in Lake Quonnipaug, 2002

Concentrations of 2,4-D in the treatment sites (Figure 4) were well below the desired concentration of 1000 ppb suggested by Green and Westerdahl (1990). The highest 2,4-D concentrations were found in water near the bottom of the east shoal treatment site where levels were 87 ppb - 1 DAT, 57 ppb - 8 DAT, 20 ppb - 13 DAT, 16 ppb - 21 DAT and below the detection limit of 1 ppb - 28 DAT. Movement of the herbicides throughout the lake was probably the reason for the low concentrations in the treatment sites. 2,4-D was found at concentrations approaching that of the treated area in both the center of the lake (treatment site +1000 ft.) and shoal west +100' site. Movement of 2,4-D may have been accelerated because of the exposed central location of the shoal treatment sites. Because control of Eurasian milfoil was very good, albeit somewhat slow, it appears the 2,4-D concentration of 1000 ppb thought necessary for good control is considerably higher than needed in Lake Quonnipaug. The irrigation standard of 100 ppb 2,4-D was not exceeded in any of the water samples.

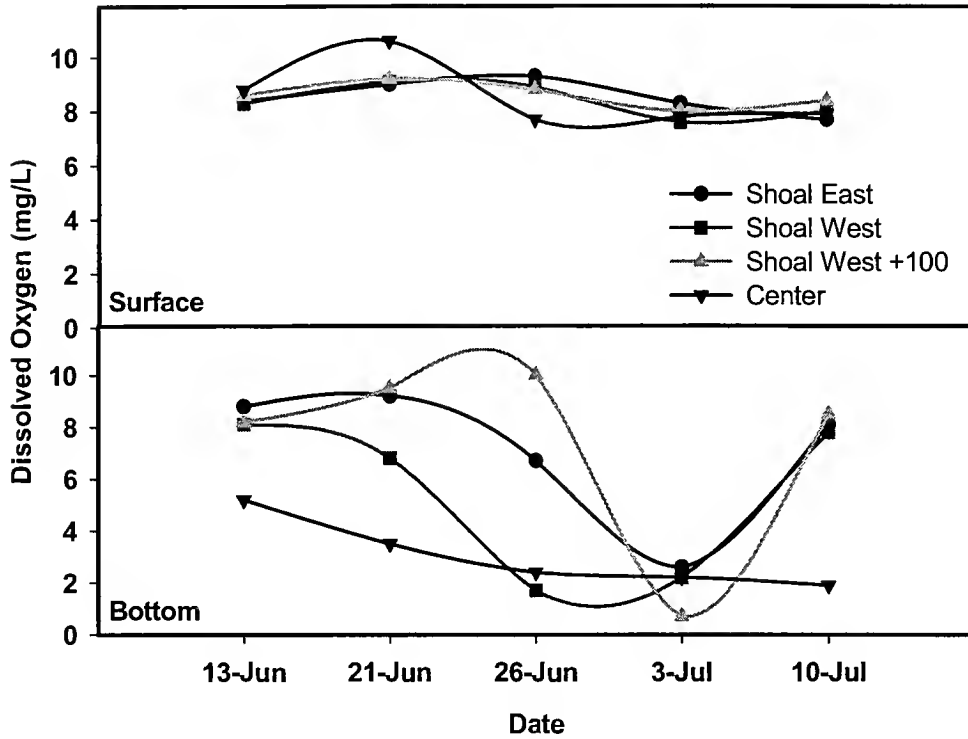
Figure 5. Dissolved oxygen in Lake Quonnipaug, 2002.

Low levels of dissolved oxygen can be associated with the decay of plant tissue when controlling unwanted vegetation with an herbicide. Tests revealed that all surface water samples contained abundant dissolved oxygen throughout the sampling period (Figure 5). In the water near the bottom, dissolved oxygen fell below a desirable level of greater than 3.0 mg/l on June 26 (13 DAT) and July 3 (21 DAT). Dissolved oxygen in these bottom water samples recovered to non-deficient conditions by July 10 (28 DAT). The brief low dissolved oxygen levels are typical in lake bottom water in the summer and did not occur solely in the treatment areas. Dieback of milfoil was, therefore, not likely the cause.

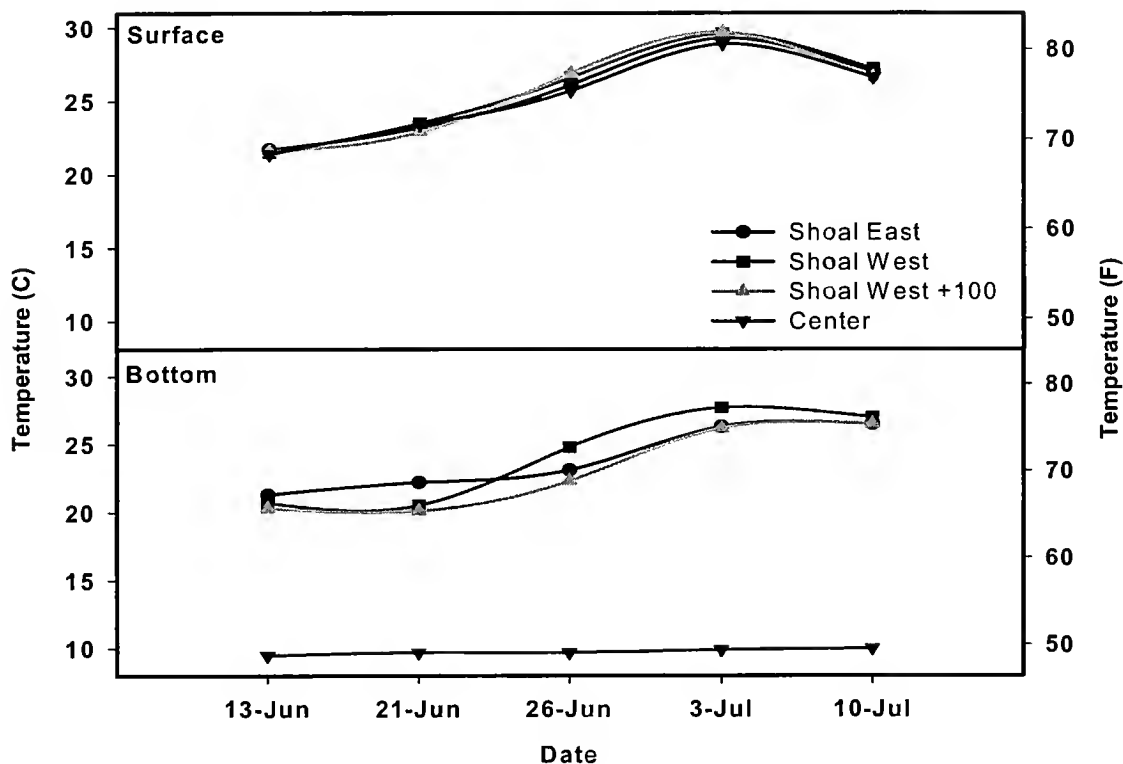
Figure 7. The water temperature in Lake Quonnipaug, 2002.

Surface-water temperatures warmed from near 70° F in mid-June to near 80° F in mid-July (Figure 7). Bottom temperatures in the treatment sites differed little from the surface. In the center of the lake, where a complete temperature profile could be determined, the thermocline (demarcation between warm surface and cool subsurface water) was at a depth of 18' on June 13 and 12' on July 10 (Figure 6). Water pH ranged from 7.1 to 7.4, while alkalinity ranged from 34.2 to 43.8 mg/l CaCO<sub>3</sub> (Figure 7). Transparency was between 2.5 to 4 meters throughout the spring and summer (Figure 8). The clearest water occurred in early July.

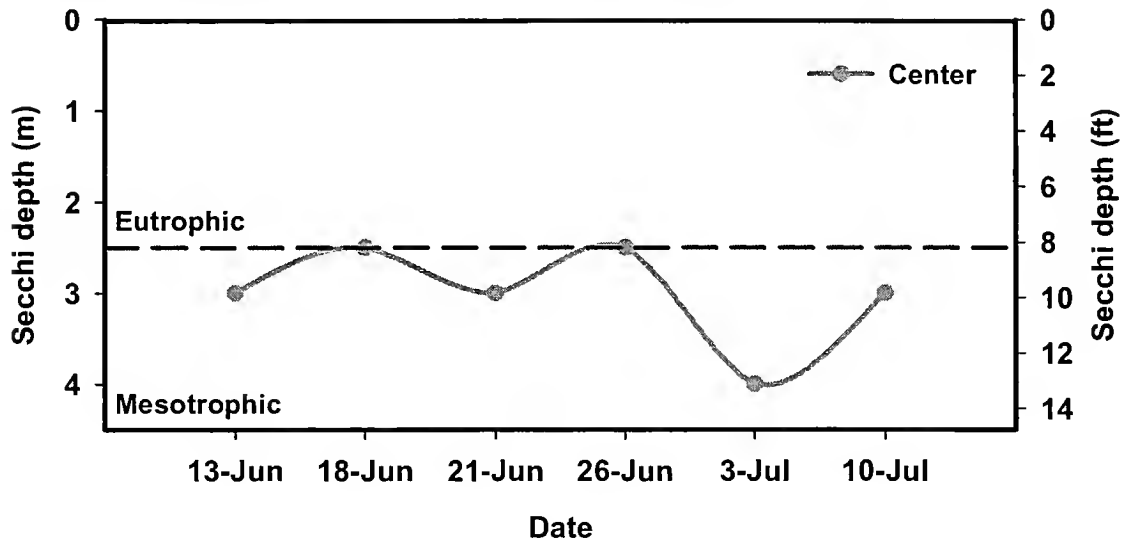
Figure 9. Transparency in Lake Quonnipaug, 2002.

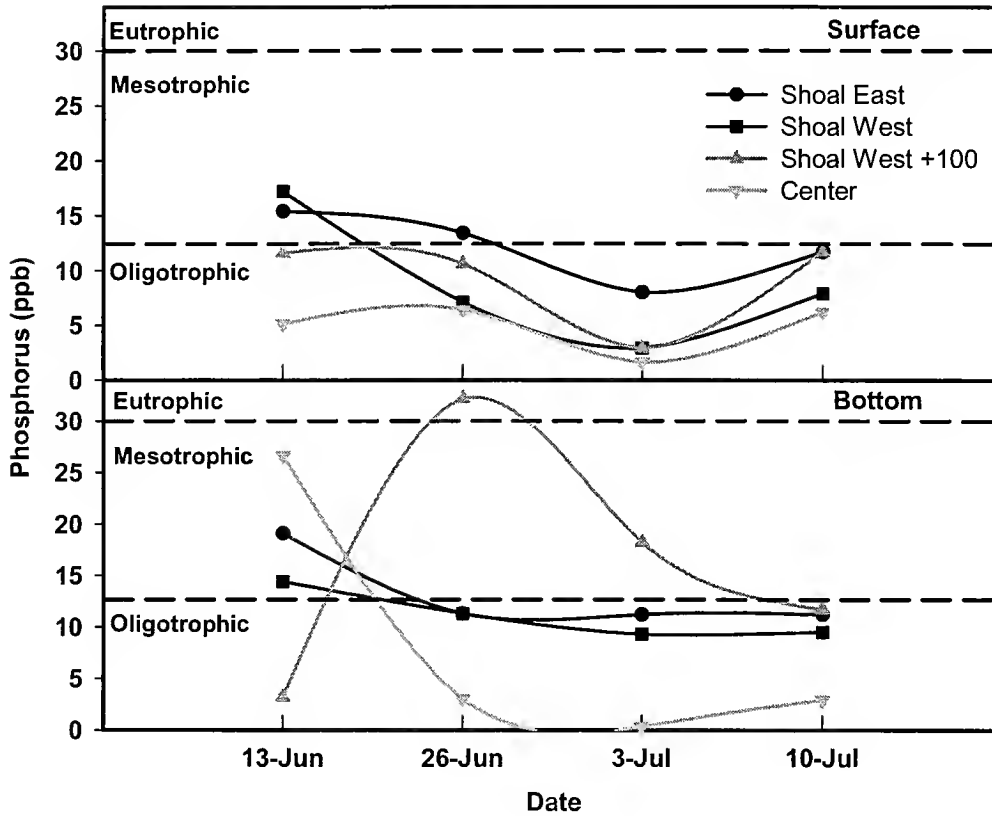
Figure 10. Total phosphorus concentrations in Lake Quonnipaug, 2002.

Total phosphorus (P) concentrations in the lake water are considered a key indicator of the state of eutrophication. Frink and Norvell (1983) reported that lakes with P levels below 15 ppb can be considered oligotrophic, lakes with P between 15 and 30 ppb are mesotrophic and lakes with P over 30 ppb are eutrophic. P concentrations during this study (Figure 9) generally ranged between 5 and 20 ppb and would classify Lake Quonnipaug as oligo/mesotrophic. This is similar to concentrations found in previous studies (Canavan and Siver, 1995; Frink and Norvell, 1983).

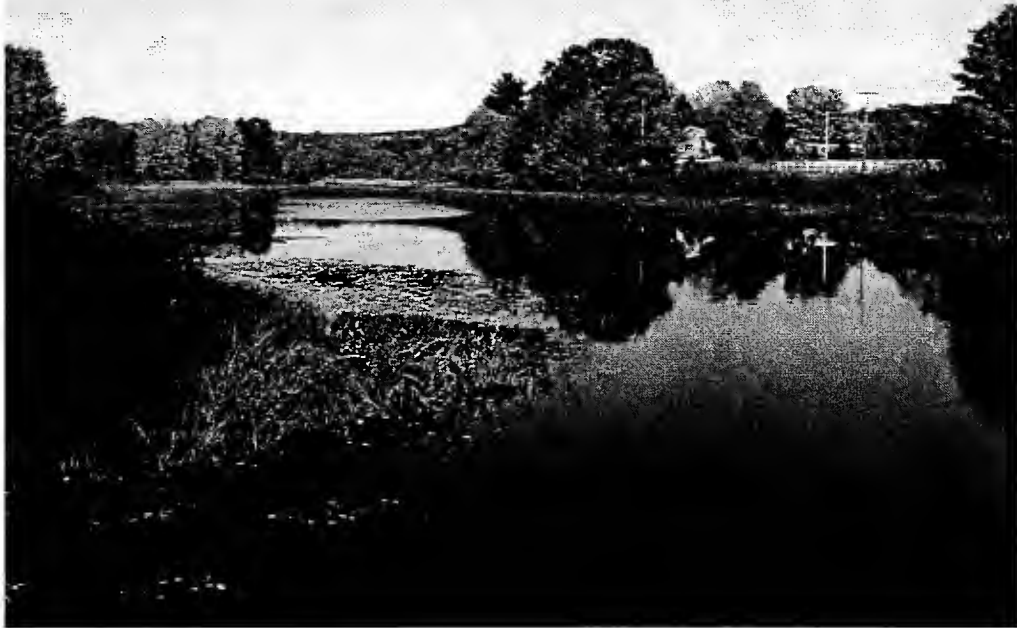
Figure 12. South cove after glyphosate application and hydroraking.

Treatment of the lily pads and other emersed vegetation with glyphosate on September 3, 2002 resulted in considerable dieback of the plants after three weeks. Enough living vegetation was apparent, however, to require a follow-up application on September 24. The uncontrolled plants could have remained because of missed plants, wash off of herbicide or lack of sensitivity of certain plant species. The effectiveness of this second application could not be fully determined because the hydroraking of the area began approximately one week later. Hydroraking appeared to remove most plants from the area shown in Figure 2. Some broken plant parts (roots, stems, tubers etc.) were floating in the water after hydroraking, but winds from the north and flow of water to south (over the dam) probably minimized their movement northward into the main body of the lake. Future monitoring is needed in areas where lily pads were removed to determine how rapid regrowth occurs and if
